Document n°	FRN-SB2010-09-washer for outer glass breaking- SC ovens					
Brandt	Smeg					
Models involved	SCP112N-8	SCT109N-8	SAP112-8	SC106-8	SC107SG-8	SCP113-8
	SCP109N-8	SCT109B-8	SA109-8	SC106SG-8	SC109-8	SCP113SG8
	SC106B-8	SC107N-8	SA112-8	SC106PZ-8	SC109SG-8	SCT105-8
	SC106N-8	SC109N-8	SAP109-8	SCT109-8	SA109M-8	SCT105SG8
	SC112N-8	SCP108RB8	SCP112-8	SCP112PZ8	SAP109M-8	SAP109-9
	SC112B-8	SCP108RN8	SCP109-8	SC112PZ-8	SCP12-8	
	SCP112B-8	SCP113N-8	SCP109SG8	SCT109SG8	SCP108R-8	
	SCP109B-8	SCT105N8	SC112-8	SCP112SG8	SCP108RS8	
Cause	<p>The wrong plastic bush position , which protects the glass (that is to say lower than the inner slot of the handle support) and the stretch occurring during the handle fixing, can affect the outer glass.</p> <p>See the following pictures.</p>					
Description of the modification	Put an additional washer p/n 764130572 into the two handle supports , under the bush protecting the glass . Follow the instructions hereafter.

Date of introduction	01/10/2010

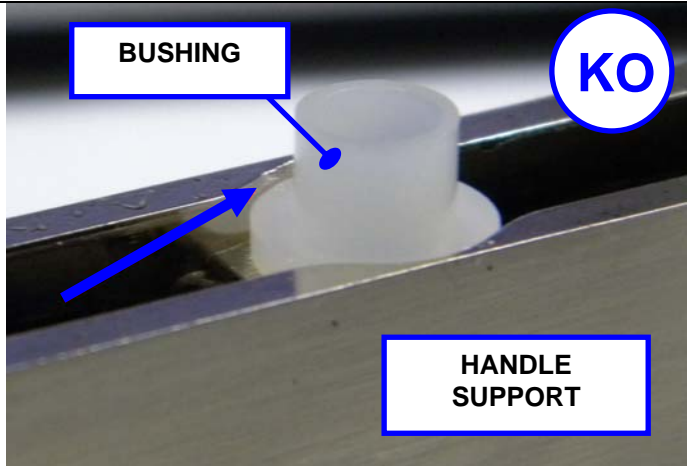
WRONG CONFIGURATION	RIGHT CONFIGURATION

A. Glass protection bush applied into the handle support. Note that the bush base is lower than the edge of the handle support.	B. Glass protection bush applied into the handle support. Note that the bush base is aligned with the edge of the handle support.

For the appliances produced **before the 1st October 2010**, owing to a outer door glass breaking, carry out the following checks and apply the washer p/n **764130572**. (under the bush which protects the glass for each handle support , right and left)
