**Technical Bulletin N° REB284**

## **Water Tube Repair Kit**

**Models Affected:**      **All SXS Ice & Water models**

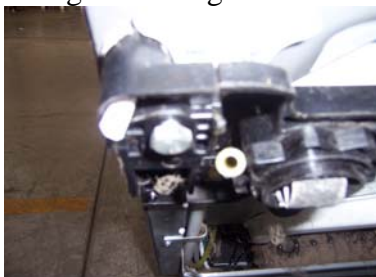
1. Cut off old tube ensuring a straight neat edge close to door panel (remove any burs)

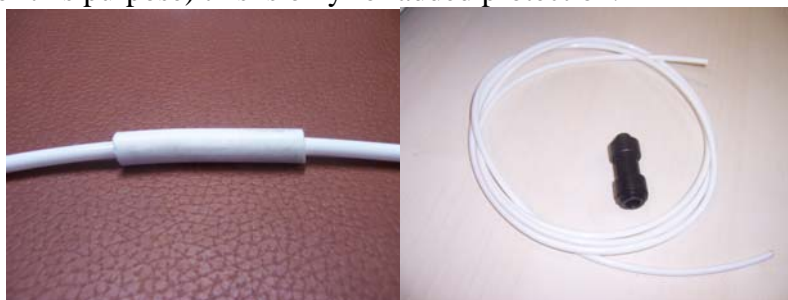
2. Insert protective sleeve (about 12 cm) over new tube supplied 1.8m length ( use a piece of old hose for this purpose) this is only for added protection.

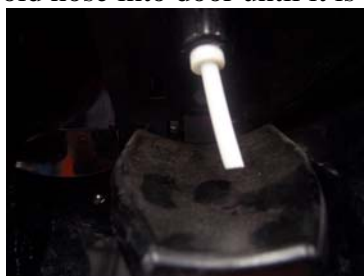
3. Insert the tube up through old hose into door until it is seen at water spout exit
