Bulletin No: REF076
Date Issued: 22/11/2016
Reference No: EHR-S053
Issued by: B. Nguyen

SERVICE BULLETIN REFRIGERATOR

MODEL: SJ244VWH, SJ308VSL, SJ308VWH, SJ339VSL, SJ339VWH.

SUBJECT: Change of connector for AC/DC fan motor.

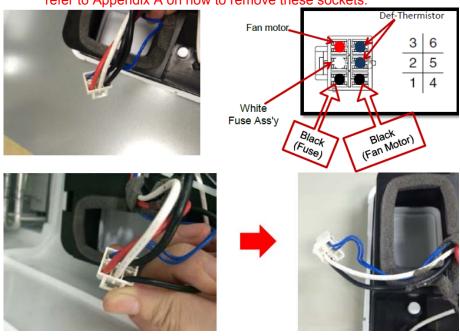
d) Carefully take off the fan cables 3 (red) and 4 (black) from the 6 pin sockets. Please refer to Appendix A on how to remove these sockets

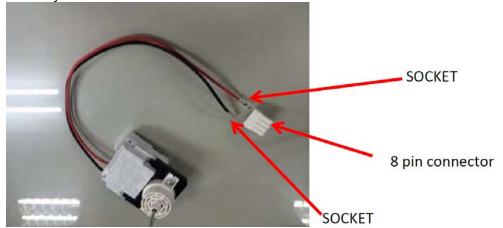
e) Carefully take off the fan cables from the socket of the fan motor RMOTRA161CBZZ.

f) Insert new fan motor (RMOTRA161CBZZ) cable in step e) to connector in step d). Note red to pin 3 and black to pin 4.

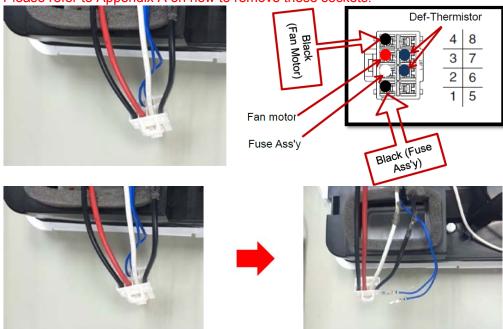
- c) Please disconnect the Def-themistor, Fuse Ass'y and fan motor connectors from F-Room to take off F-Louver ass'y prior replacing new fan motor.
- d) Carefully take off Def thermistor cables 6 (blue) & 7 (blue) from the old 8 pin socket. Please refer to Appendix A on how to remove these sockets.

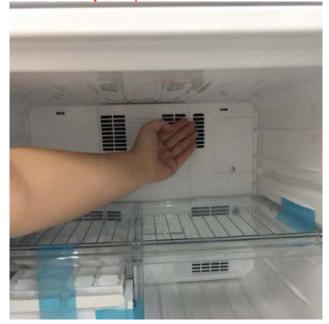
j) Turn on the power of the fridge and check the air flow of the new fan. If there is no air flow then check for incorrect assemble of the fan socket. Note if the refrigerator was power off for less than 6 minute then the compressor may be in lock mode hence the fan may not operate.

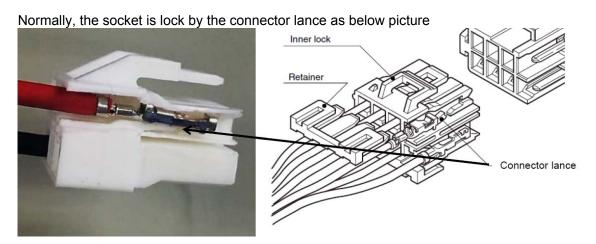
APPENDIX A: How to remove the socket from fan connector

So in order to remove the socket you need a needle or brooch similar to below

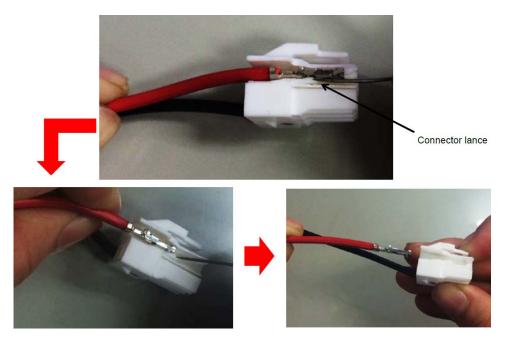
Simultaneously use a needle to press on connector lance in opposite direction of socket and pull the wire at the same time

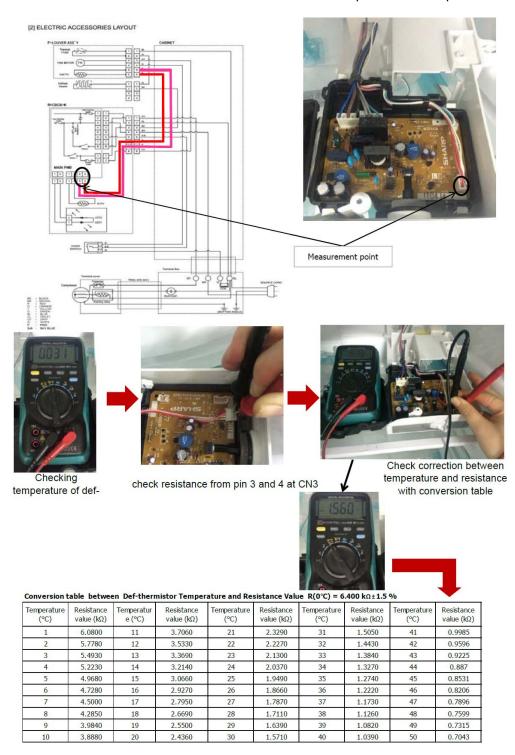
APPENDIX B: Checking defrost thermistor and its connection

Using the multi-meter measure whether the temperature resistance value of defrost thermistor is correct as per conversion table below. Please disconnect the connector "CN3" on the PWB and measure the resistance value between pin 3 and 4 as per below.
