DISHWASHER ERROR CODE E8 - ALTERNATIVE VALVE

E8 – Defective alternate valve functioning

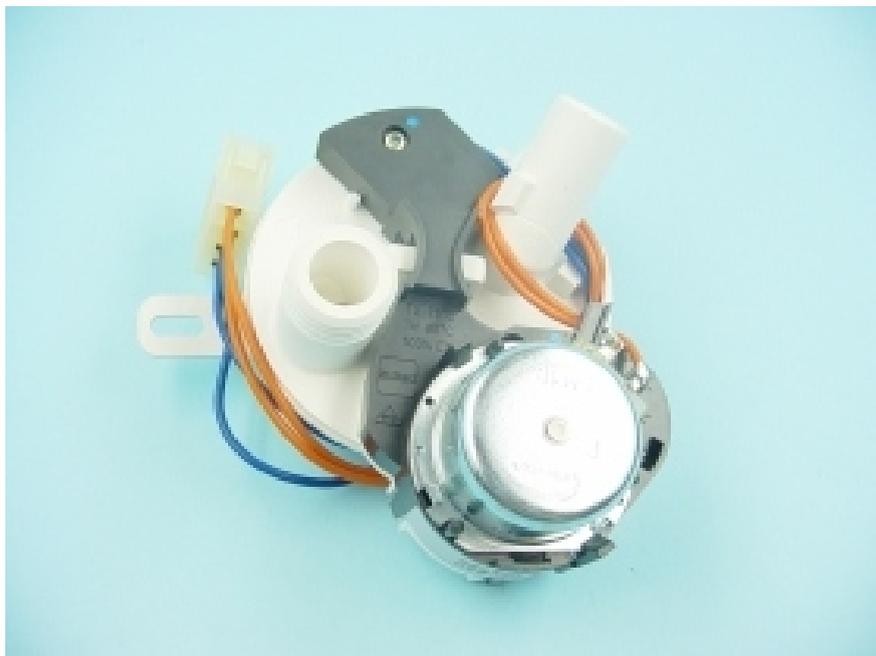
The alternative valve is a component that distributes water between the upper and lower spray arms within the dishwasher. The advantage of this is that less water is required for each wash.

The alternative valve is located in the base of the appliance and is sometimes referred to as a diverter valve or alternate valve.

An example of an alternative valve

This error code is generated when the dishwasher programme starts and the appliance does not detect a signal from the alternative valve saying that the alternative valve is correctly positioned. This defect can be caused by, but not only, a defective alternate valve.
