SERVICE BULLETIN

Document n°	CUC-SB2006-01-New microswitch on cooker door-GB
Brand	Smeg
Models envolved	Freestanding cookers 90x60,90X60PB, 60x60,60x50,80X50PB, 80x50T
Cause	Improvement of microswitch efficiency
Description of modification	The door receiver+microswitch assy have been replaced by an independent microswitch fixed directly on the oven front frame and by a door receiver. For this reason the frontal part of the oven has been modified, adding a hole for the microswitch (see details)
Date of introduction	From 07/10/05 onwards
Interchangeability	NO -- The new microswitch cannot be mounted on the appliances produced before this date, as there is no hole in the front part of the oven to fix it.

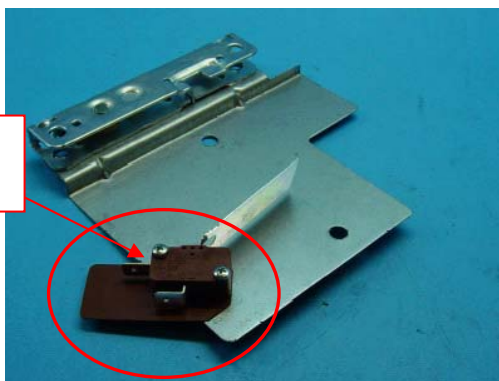
MICROSWITCH
PARTNO
814490491

OLD CONFIGURATION

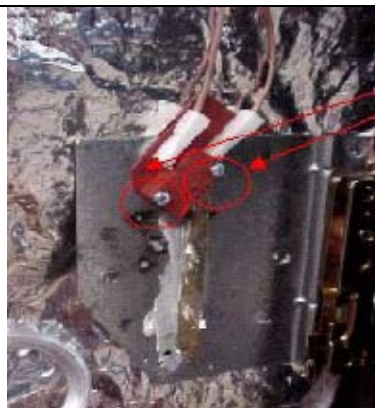
DOOR RECEIVER ASSY PART N° 695970056

DETAILS OF SWITCH FIXED TO DOOR RECEIVER

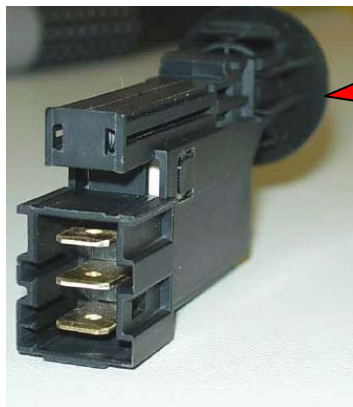
DETAIL MICROSWITCH
PART NO. 814490636

The door receiver+microswitch assy and the oven front part have been replaced with: a new microswitch, the related support for the fixing, a new oven front part and an independent receiver has been added replacing the old door receiver+ microswitch assy.
